**DRAFT REPORT
ROUND 10 DAM ASSESSMENT - MAY 18, 2011
PPL GENERATION, LLC.
BRUNNER ISLAND POWER STATION
ASH BASIN NO. 6 WITH POLISHING POND, EQUALIZATION POND AND
INCIDENTAL WASTE TREATMENT BASIN (IWTB)
YORK HAVEN, PENNSYLVANIA**

**GZA GeoEnvironmental, Inc.
One Edgewater Drive
Norwood, Ma 02062
GZA File No. 01.0170142.30**

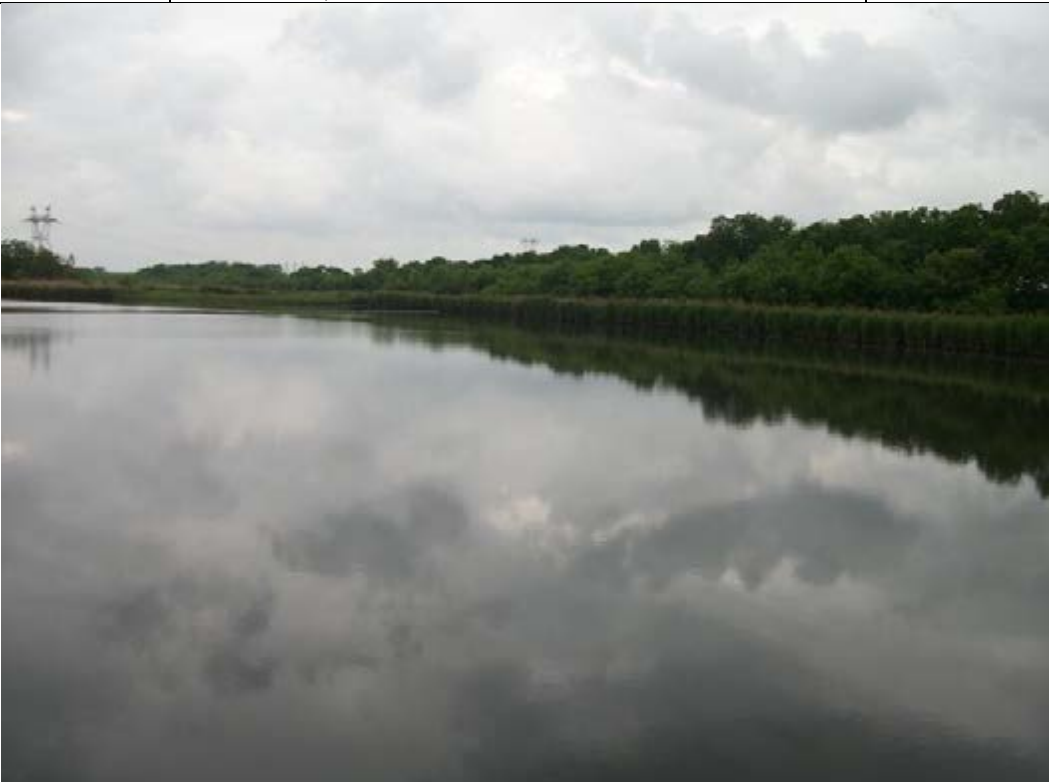
Direction Photo Taken: Northerly			
Description: Overview of east side of Ash Basin No. 6 as viewed from the decant intake structure. Note high vegetation/reeds along inside slope of basin.

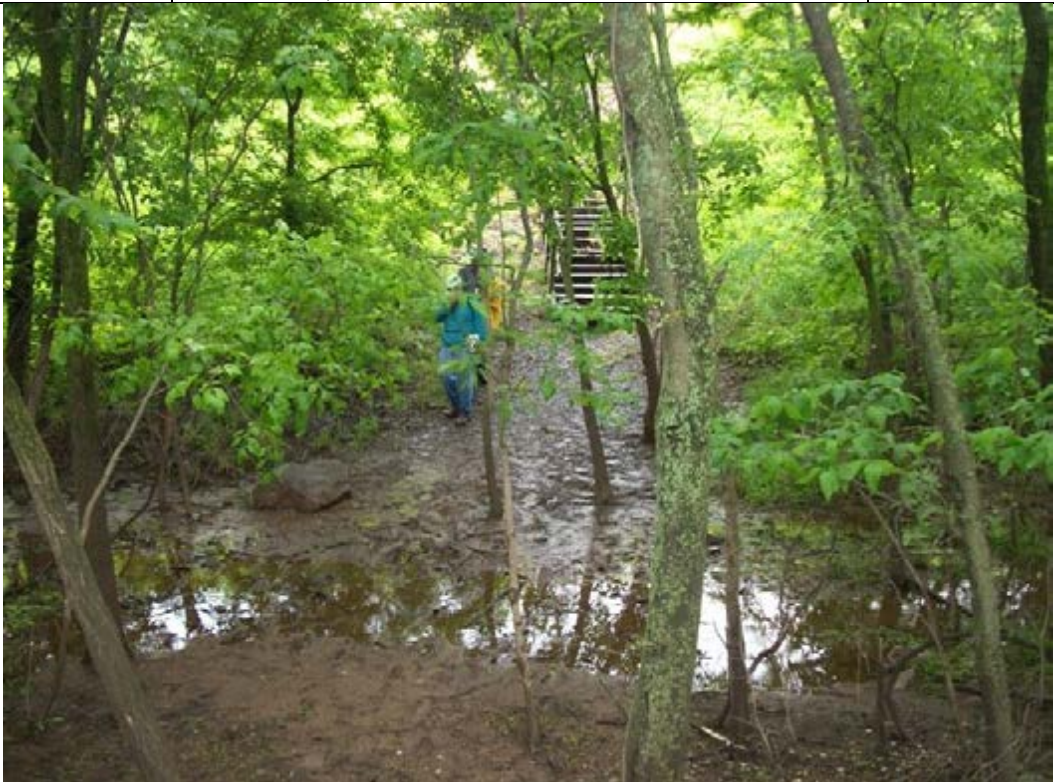
Direction Photo Taken: Westerly				
Description: Standing water observed just beyond toe of east side embankment. According to Plant Representatives this water is likely remnants of previous weeks flooding along the Susquehanna River.				
Photo No. 14	Date: 5/18/2011

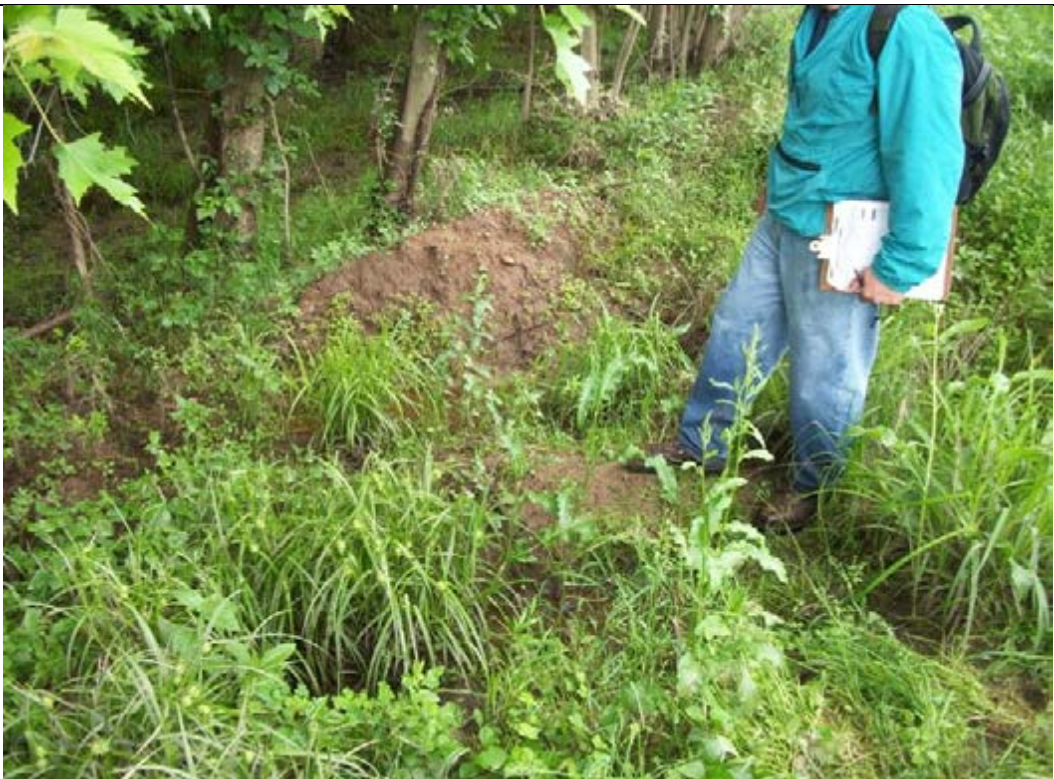
Direction Photo Taken: Southeasterly				
Description: Localized scarp/erosion observed scarp near toe of embankment on the east side.

1. Repair sloughs and scarps on the embankment and provide future erosion protection as necessary.

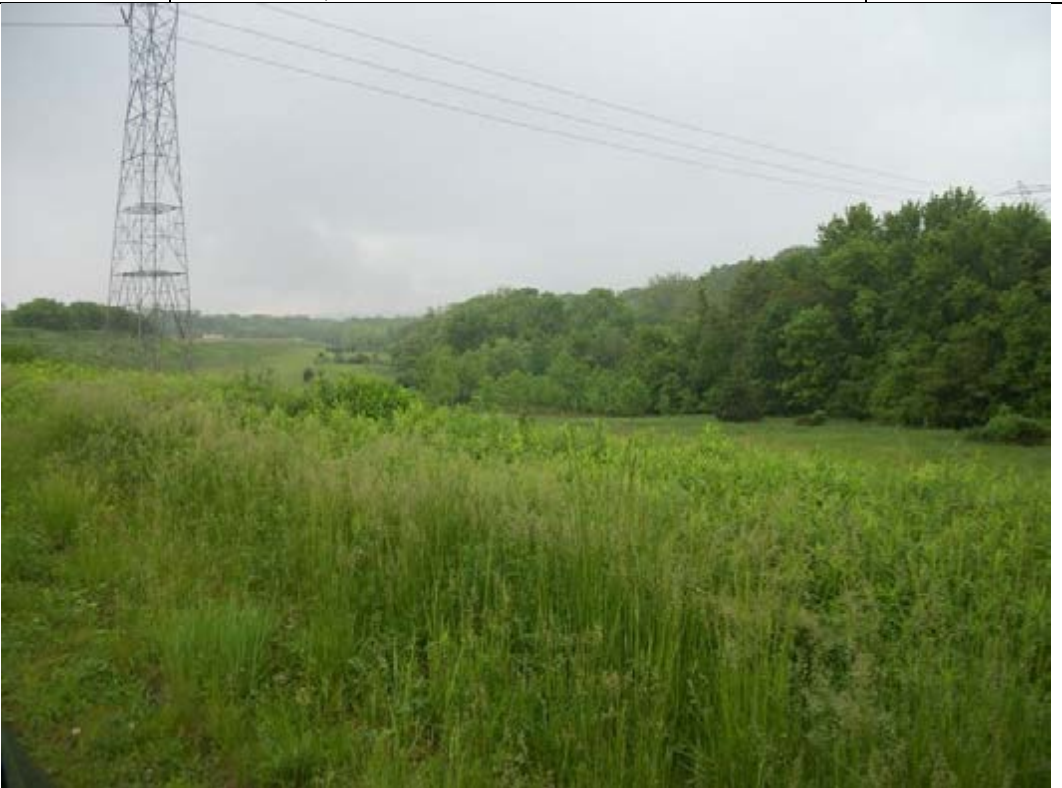
Direction Photo Taken: Southerly			
Description: View of outside slope and toe area beyond along the west side of Ash Basin No. 6 near the north end looking south. Note high vegetation particularly on slope. Annual mowing normally occurs in June.

1. Maintain grass cover on the downstream slope and approximately 15 feet beyond the toe area. USACE recommends vegetation be kept less than 12 inches in height on embankments. This may required mowing more frequently than bi-annually.
2. Fill ruts, depressions, and animal burrows and reseed if necessary.
3. Monitor and repair sloughing at the inside slope at the Polishing Pond and outside slope at the east embankment, or other locations sloughing is observed.
4. Exercise stoplogs and slide gates at least once annually.
5. Monitor spongy/soft ground observed at the east embankment.

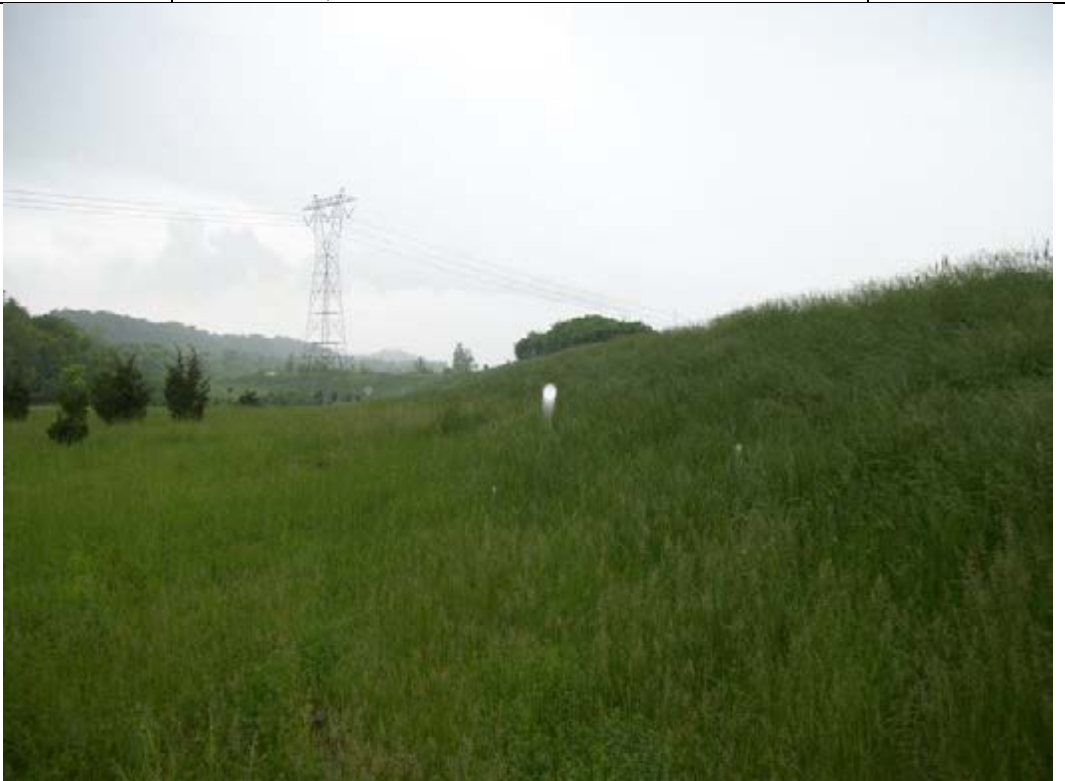
Direction Photo Taken: Northwesterly			
Description: Close-up view of west side embankment looking north. Note knee-high vegetation precluded close visual inspection. Annual mowing occurs in June.

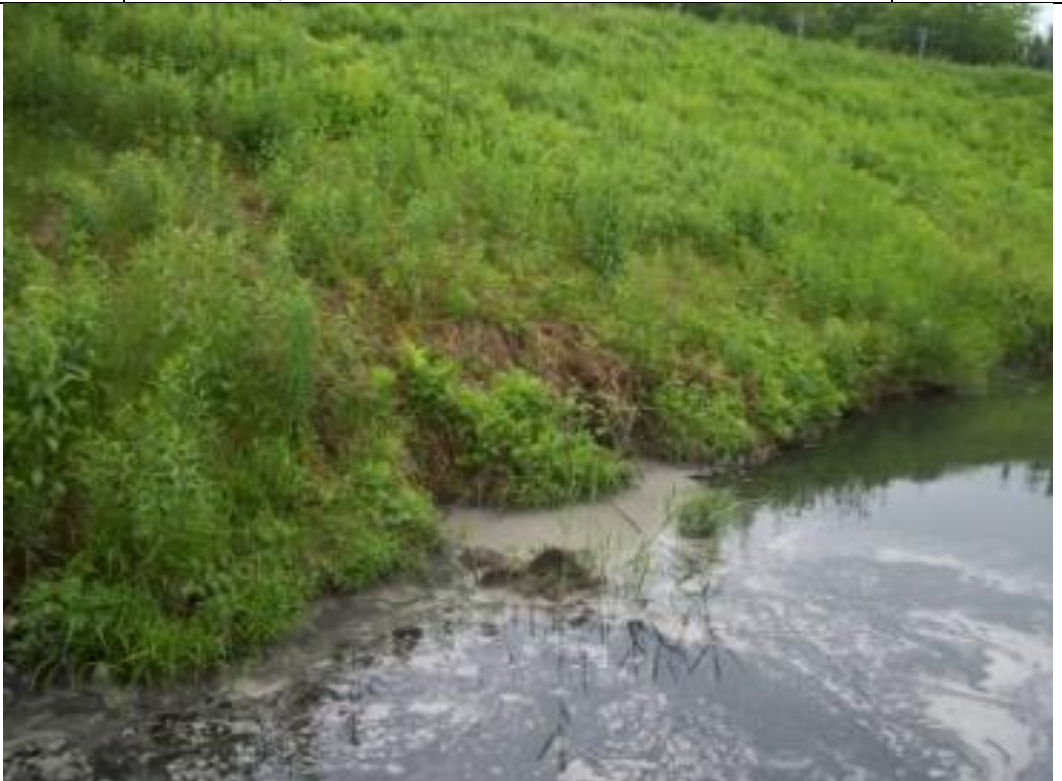
5. Sloughing observed at inside slope of the Polishing Pond, especially near the water line at the east side. Sloughs and scarps observed generally less than 3 feet deep.

Direction Photo Taken: Southeasterly			
Description: Small scarp near waterline observed on inside slope on east side.

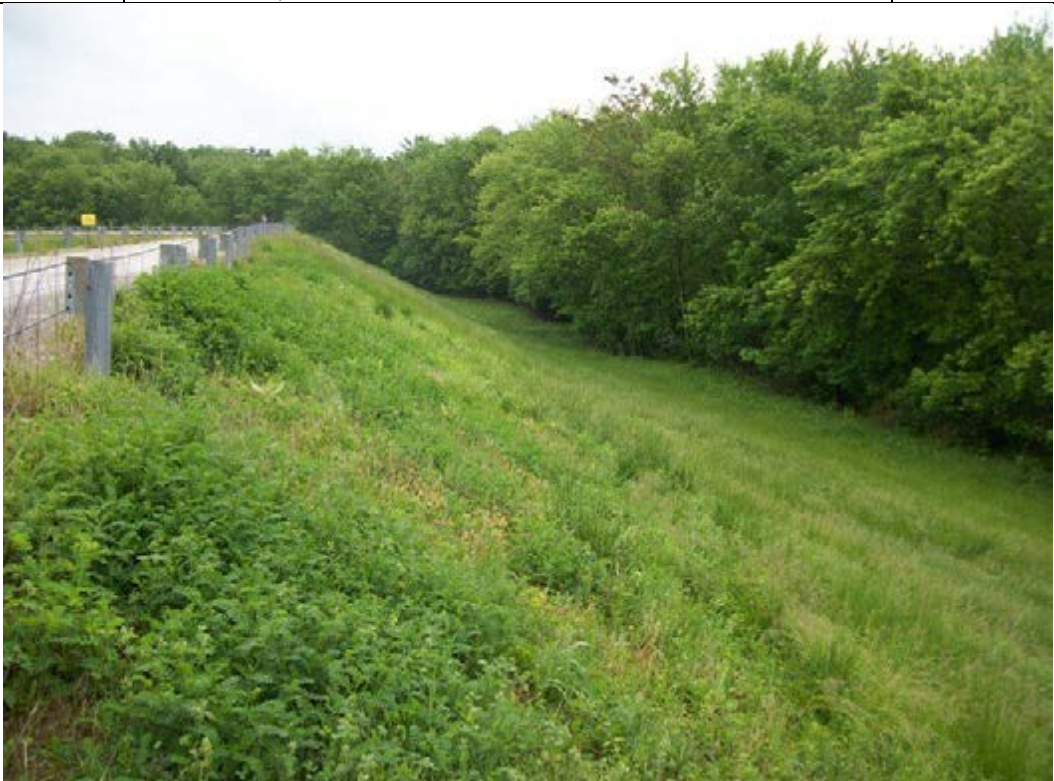
Direction Photo Taken: Southerly			
Description: Outside slope along west embankment. Note knee-high vegetation precluded close visual inspection. Annual mowing occurs in June.

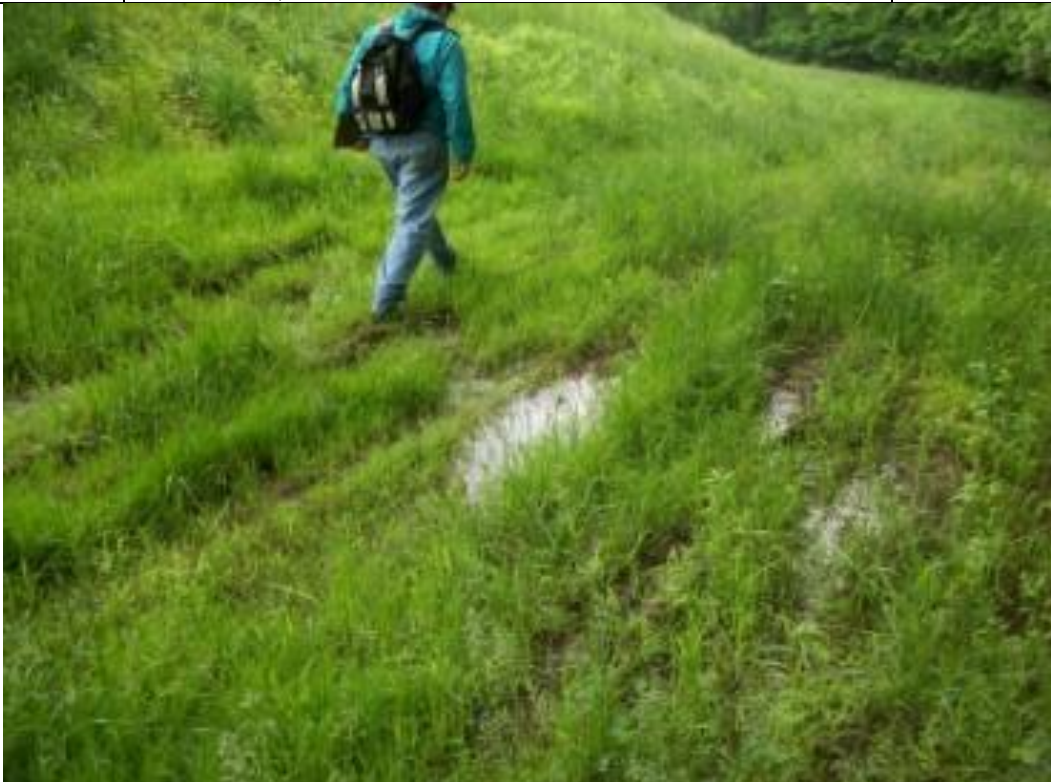
3. Ruts and depressions observed at portions of the embankment toe from vehicles.
4. Saturated portions of embankment and standing water observed at the toe of dam at various locations around the polishing pond and east embankment. Conditions possibly due to heavy rainfall over the prior week. According to PPL personnel waters of the Susquehanna River had recently receded from the areas surrounding the toe of the embankment, which may also have contributed to the standing water and saturated conditions.

Direction Photo Taken: Southeasterly			
Description: Ruts observed along toe of west embankment. It appears that standing water is more a result of recent heavy rainfall rather than seepage through the embankment.

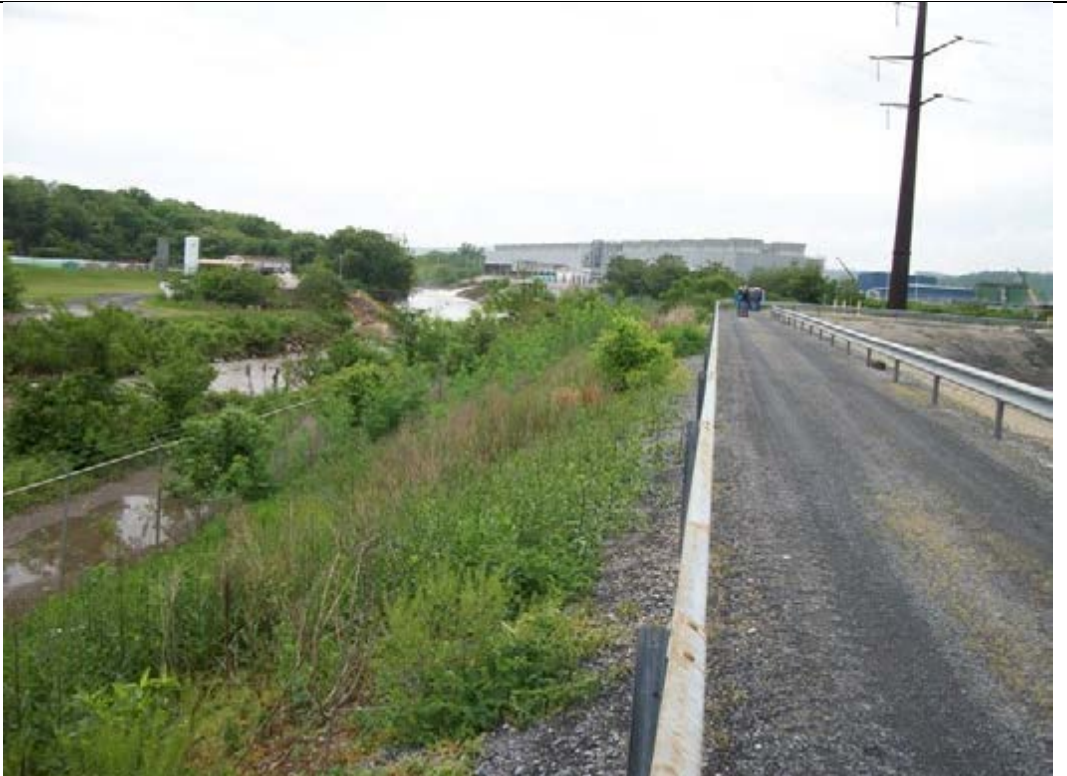
Direction Photo Taken: Southeasterly		
Description: Outside slope of east embankment as viewed from the north. Shrubbery and high vegetation.

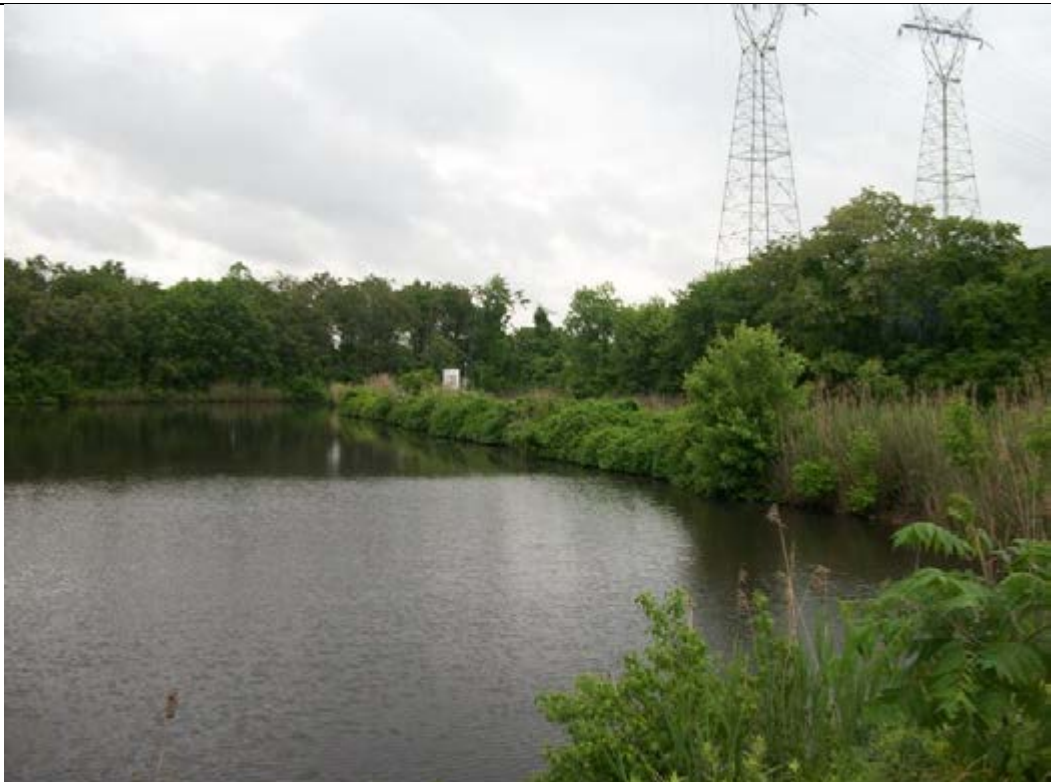
Direction Photo Taken: Easterly		
Description: View of inside slope of south side dike at the south lagoon. Note heavy vegetation and shrubbery precluded close visual inspection of slope.

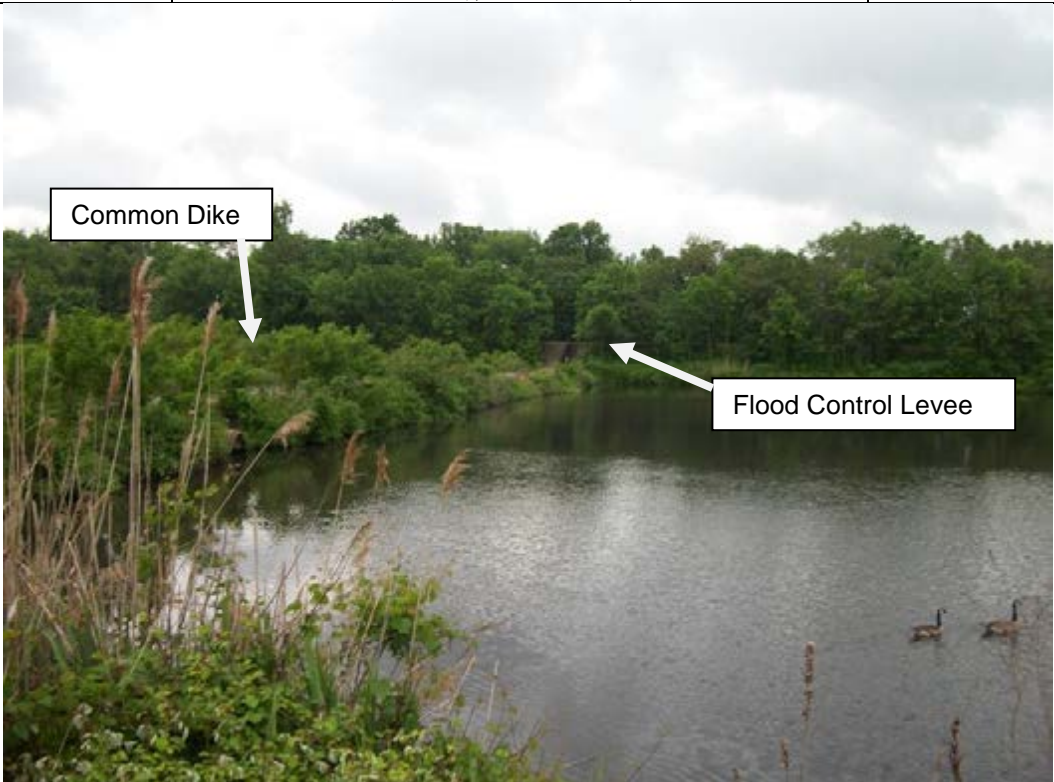
Direction Photo Taken: Northeasterly			
Description: (At left) view of inside slope of common dike between the middle and south lagoons. Note heavy shrub/small tree growth and high vegetation. Also note the higher elevation Susquehanna Flood Control Levee in the background which forms the east side of the north, middle and south lagoons.			
Photo No. 52	Date: 5/18/2011

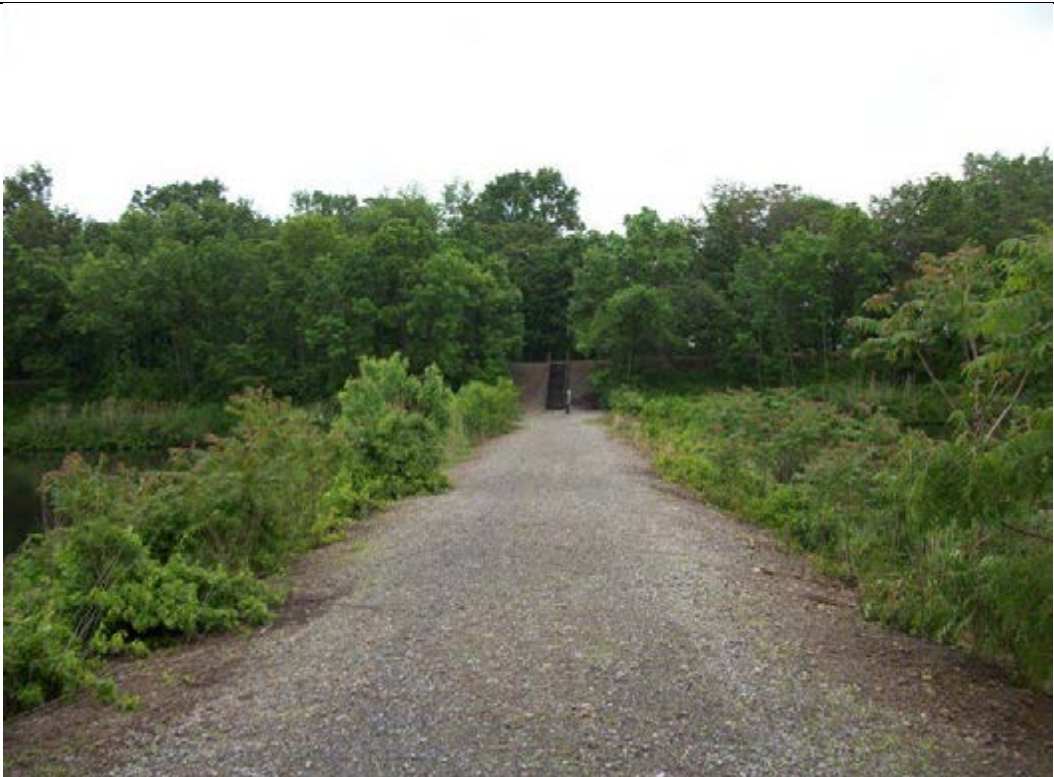
Direction Photo Taken: Northeasterly			
Description: Crest of common dike between the middle and south lagoons. Note overgrown vegetation on slopes. Staircase at end of dike leads up to crest of Susquehanna Flood Control Levee which borders the east side of the north, middle and south lagoons.

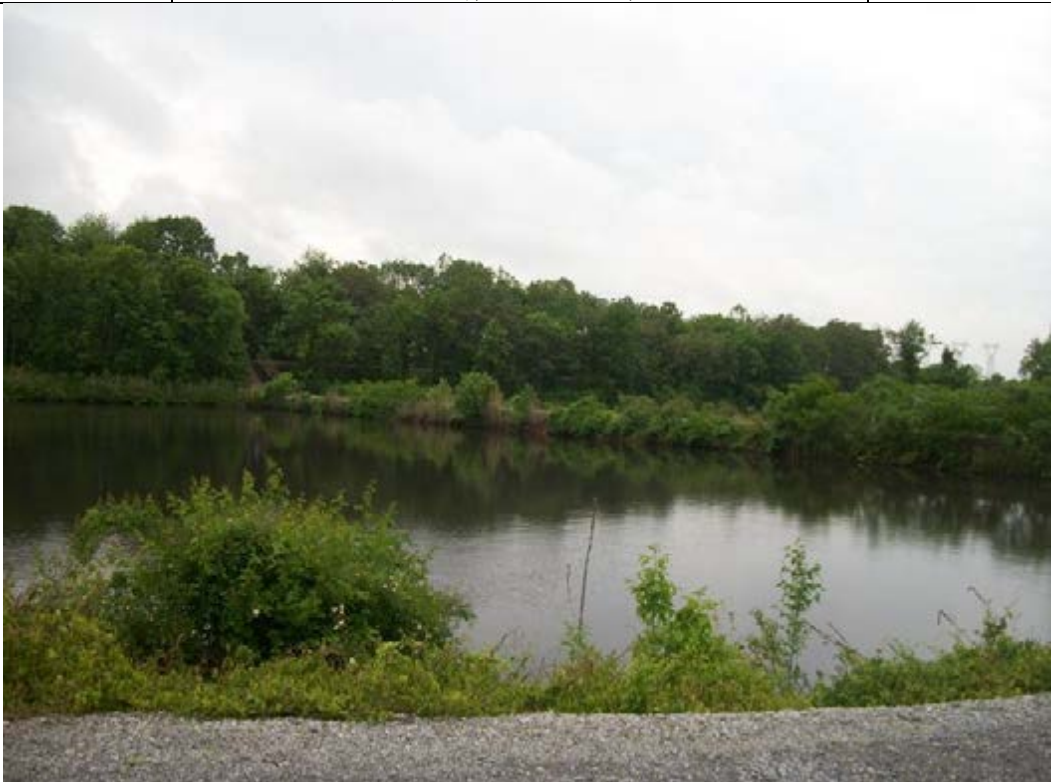
Direction Photo Taken: Easterly			
Description: Overview of middle lagoon from western end. Note moderate to heavy vegetation, shrubbery and small trees along inside slopes.

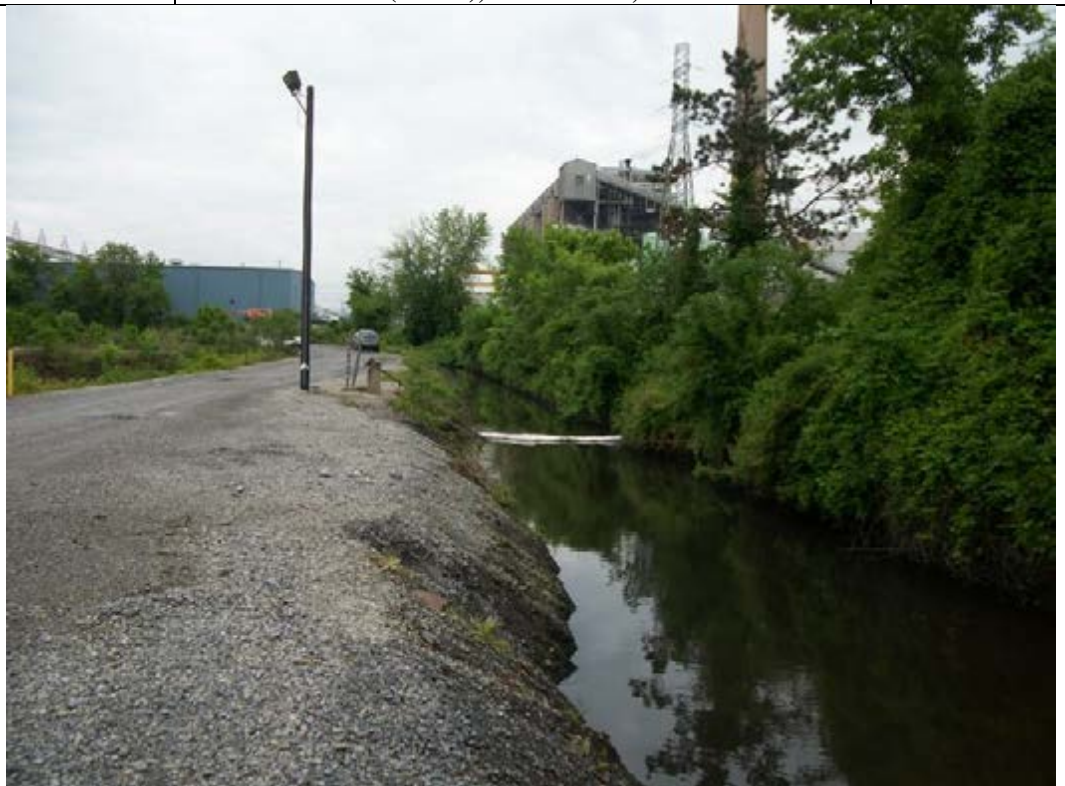
Direction Photo Taken: Southeasterly			
Description: Overview of canal along western side of IWTB looking southeasterly. Note minor to moderate erosion/scarps along slope.

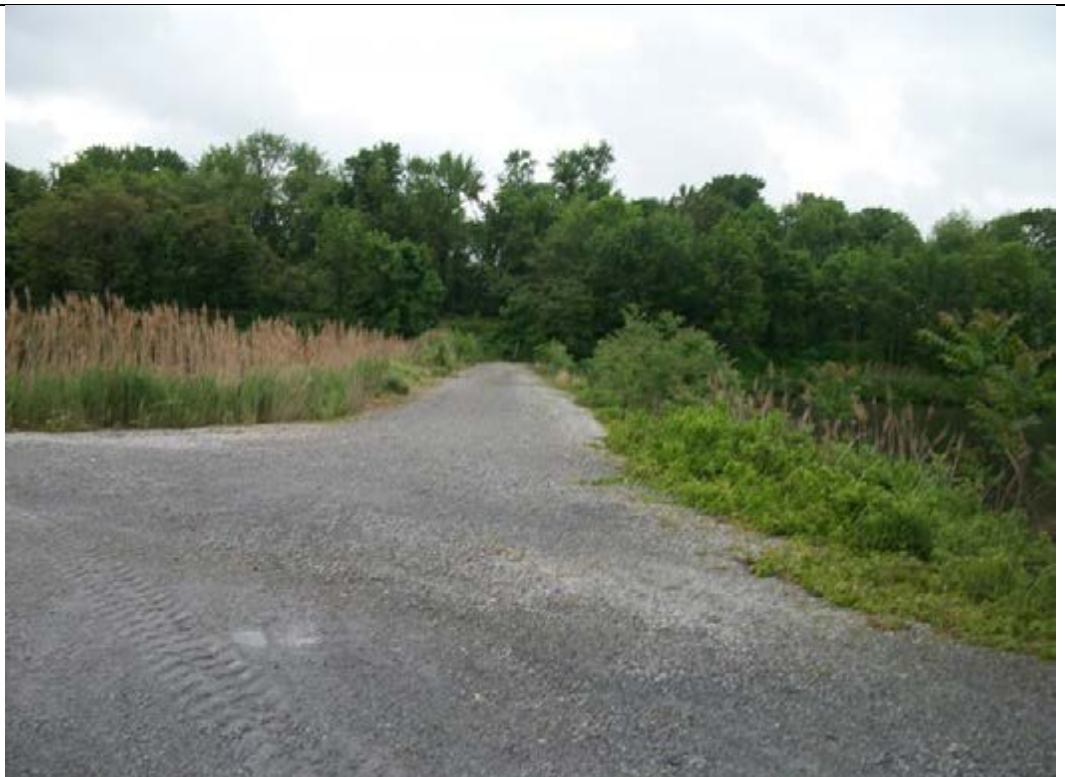
Direction Photo Taken: Northeasterly		
Description: Crest of common dike between middle and north lagoons. Note moderate to heavy vegetation, shrubbery and small trees along inside slopes.
